## THE FORTIFIED MANOR HOUSE AT NEWTON ST. LOE INTERIM REPORT ON THE EXCAVATIONS

## C. J. ARNOLD

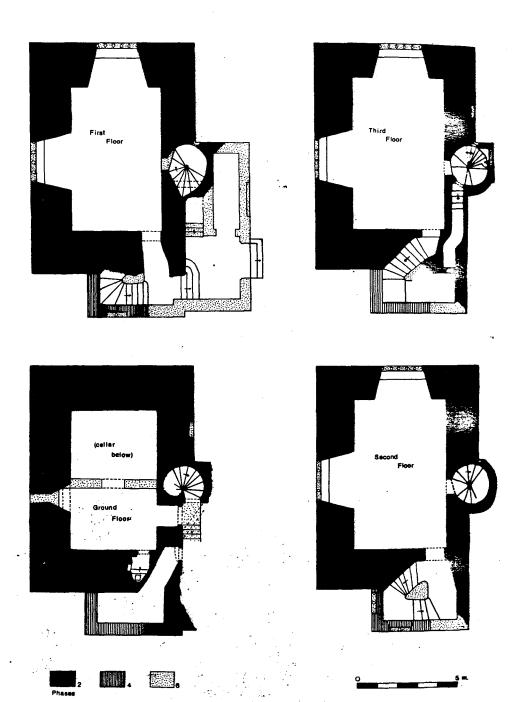
Fig. 3. Newton St. Loe: floor plans of the keep.

The keep (fig. 2), constructed in the early fourteenth century, is of four storeys. The ground floor consists of a chamber with a central, splayed window on the east side, fireplace on the south, garderobe on the north, with the entrance to the west. In the southern half of the chamber is a cellar, below. In the eighteenth century a barrel vault was inserted supported by a cross wall which blocked the window. The original layout of the ground floor is repeated above. Access was by means of a spiral staircase which begins beside the entrance to the ground floor chamber and is lighted by tiny windows on the south side. From the uppermost floor access was available through a doorway (now blocked) to the west, direct from the staircase, onto the wall walk of a building whose gable roof line is preserved on the west wall of the keep. Similar access was provided to the north by a passage through the west wall with an external door jamb at the end, where it now terminates at the modern stairwell. The present entrances from the modern stairwell into the rooms of the upper three floors are directly over the entrance to the garderobe of the ground floor. In the sixteenth century a projection was built on the north side, probably to provide more extensive garderobe facilities, although now forming the modern stairwell. At a similar date three tiers of four-light transomed windows were added on the south and east sides, which were restored in 1945. The crenellations, like the porch on the west side, are of Bath stone, and are certainly not original work; they are perhaps best viewed as eighteenth-century additions. The outside face of the parapet carries, amongst others now very worn, the arms of the St. Loe family with three points, and the arms of Botreaux.

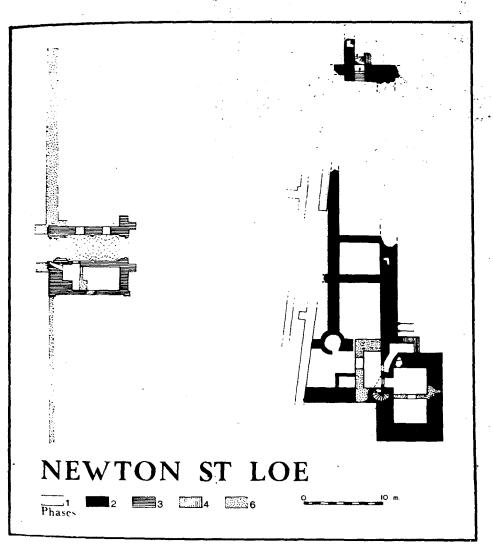
Fig. 2. Newton St. Loe: plan of the excavated and standing structures.

Phase 2 The major construction phase was confined to the late thirteenth or early fourteenth century, when an L-shaped structure was erected with the surviving keep in the angle. The western wing consisted of two parallel walls, abutting against a section of the eastern side of the walls of Phase 1. Much of the interior of this structure was destroyed either during or after its demolition, although part of the pennant sandstone flagging and a cellar survived. In the north wall, in the angle with the north wing, was a spiral staircase with jambs indicating that access was, unusually, possible both to the interior of the west wing and externally. Thus, the keep was provided with a separate staircase to which access could only be gained from the ground floor of the west wing, which had a separate isolated means of access to its upper floors. The southern wall of the wing was considerably thicker than the northern.

The north wing consisted of two chambers with flagstone floors, the northern chamber being the smaller. The east wall of this wing was thicker than the west. To the east of the wing, in the angle with the keep, the bedrock had been cut away to a depth of at least 2m, either forming a continuous ditch along the outside of the wing or, more probably, as a garderobe pit, fed by the series of garderobes in the north wall of the keep. A garderobe was also present in the east wall of the wing.

Excavation (fig. 3) has been directed towards areas on the north and west sides of the keep. Other archaeological sites have been identified and surveyed within the parish (fig. 1) including two deserted-settlements, possibly of medieval date. One lies astride the eroded remains of Wansdyke which traverses the Park (ST 689636), the other immediately outside the valley (ST 651636). The earliest surviving part of the the present village of Newton St. Loe is the church, particularly the south aisle and perch. which are of early fourteenth-century date. The present village site may have been established to allow the clearance of earlier settlements within the park.

sub-divided into a series of phases (fig. 3).

The gatehouse (fig. 3), of the middle of the fifteenth century, consists of a passage vaulted in two bays with an open arcade on the north side and a door into a side chamber on the south. This room is matched by another on the first floor with a large chamber over the passage. The entrance to the gate reveals the grooves for a portcullis, with a gunloop on the south side, and the surviving pair of doors may be original. This building was also altered in the eighteenth century with the addition of small, square angle 'towers' on either side of the entrance and continuous crenellations between. There are no indications of buildings originally abutting the gatehouse, apart from the scar of the original curtain wall on the south side replaced in the eighteenth century by a narrow garden wall which also continues to the north. A blocked doorway survives on the south side on the ground floor. Serious subsidence on the west side of the gate house has been checked by the addition of a pair of massive
